Manhole Inspection Summary

Manhole # S25EE1025MH

Insp Date: **1/23/07 10:51 AM**

Location Address: **1023 39TH ST**

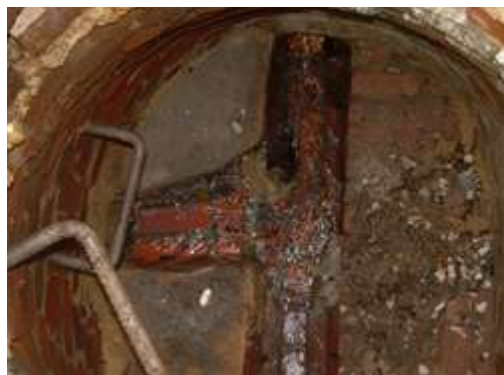
Top View

Evidence of surcharge - Bench debris.
Channel debris.

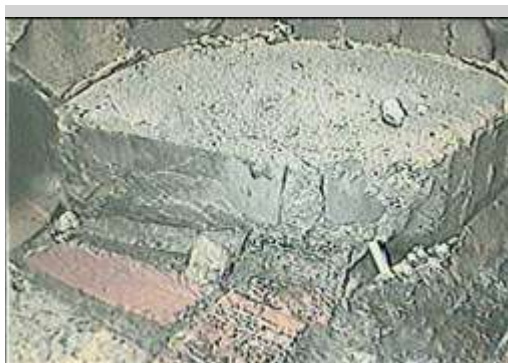
Defect

Channel deterioration.

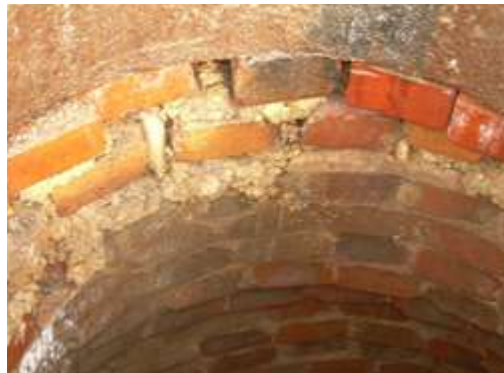
Defect

Frame leaks. Adjustment deterioration,
loose brick and infiltration.

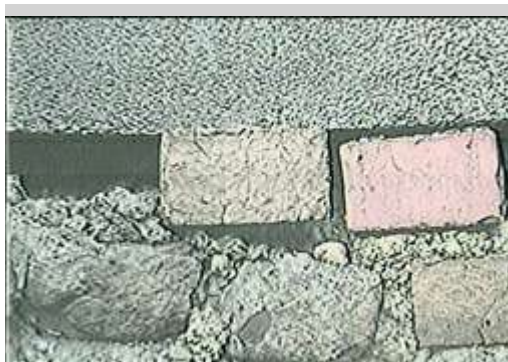
Defect

Frame leaks. Adjustment deterioration,
loose brick and infiltration.

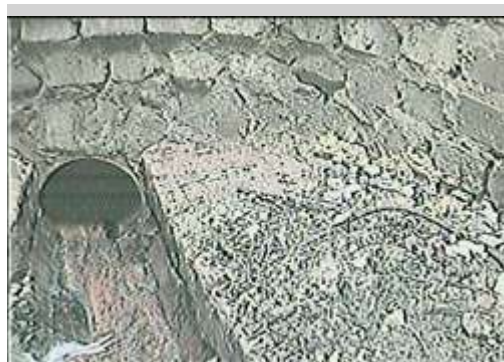
Defect

Barrel deterioration and infiltration. Bench
debris

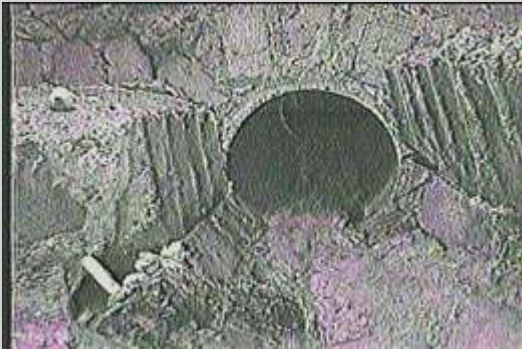
8 in. Circular Gravity Sewer Pipe Out @ 12 O'Clock

Barrel deterioration and infiltration. Channel deterioration.

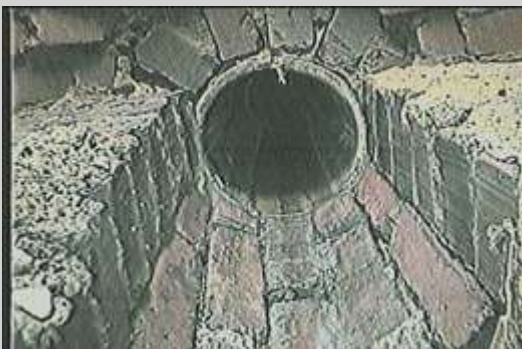
8 in. Circular Gravity Sewer Pipe In @ 6 O'Clock

Barrel deterioration and infiltration. Channel deterioration.

Infiltration: **Evidence** Pipe Seal Cond: **Unknown**
